Case study: Use of Vitoss BA and VariAx Clavicle Locking Plate System for a Clavicle Nonunion

A review by Kenneth Koval, MD

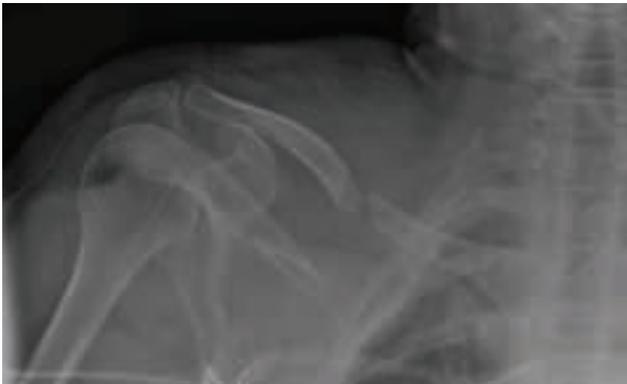
Figure 1: 65 year old woma s/p MVA. initial radiographs

Patient is a 65 year old female who sustained multiple injuries in a motor vehicle accident, including a tibial plateau fracture, cervical spine injury and a displaced distracted right clavicle fracture (Figure 1). Treatment of the cervical spine injury was prioritized and required a cervical orthosis, which could not be removed. Due to the cervical orthosis her clavicle fracture was treated non-operatively with a sling.

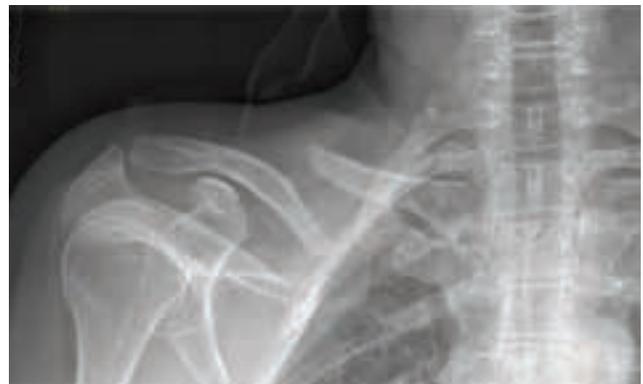
Figure 2: 5 months after injury

Patient returned at 5 months post injury with continued pain, tenderness, and deformity around her right clavicle. Radiographs demonstrated a clavicle nonunion (Figure 2). It was determined that she was a candidate for an open reduction and internal fixation.

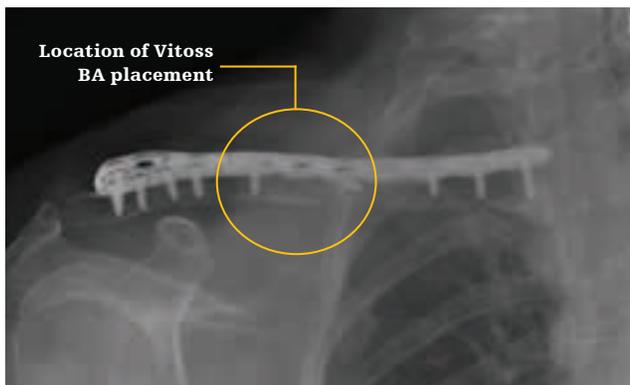
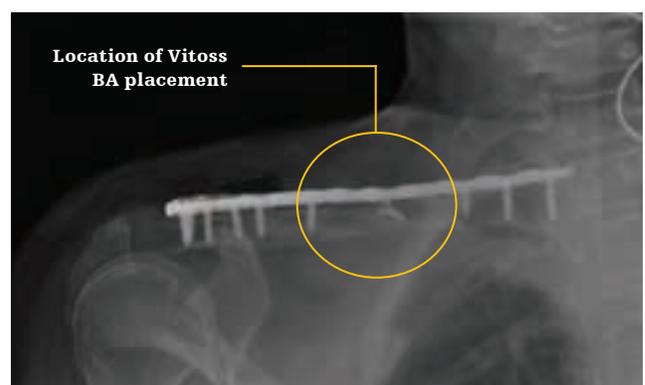
Figure 3B:

Figure 3A: Surgical treatment with Stryker plate and Vitoss BA

Surgery was performed with an incision directly over the clavicle with a takedown of the nonunion, mobilization of the fragments, and stabilization with the VariAx Clavicle Locking Plate System Superior Lateral Plate. Vitoss BA, hydrated with blood from the surgical site, was used to graft the nonunion. (Figure 3A and 3B)

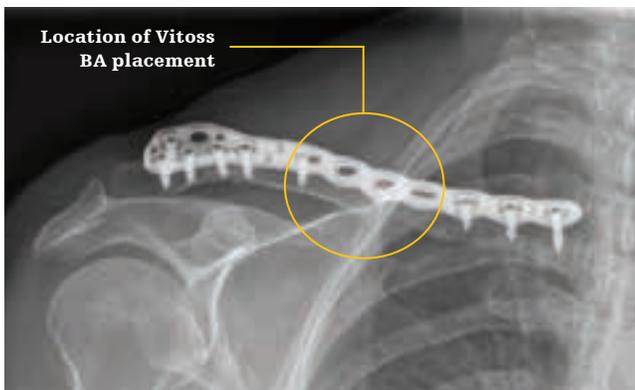
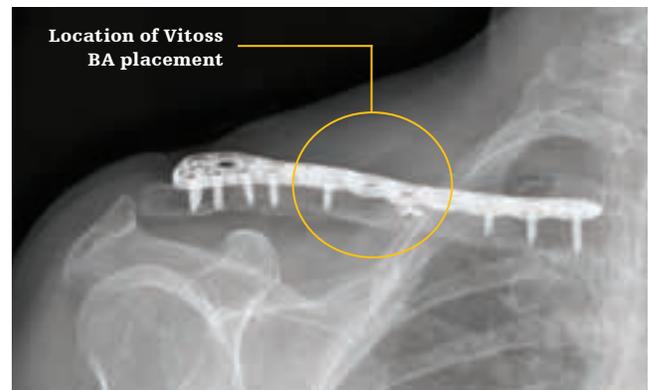
Figure 4B:

Figure 4A: 3 months after surgery

Patient was seen for 3 month (Figure 4A and 4B) and 6 month follow-up (Figure 5A and 5B) and did well clinically. The clavicle united uneventfully with the patient regaining full painless shoulder motion.

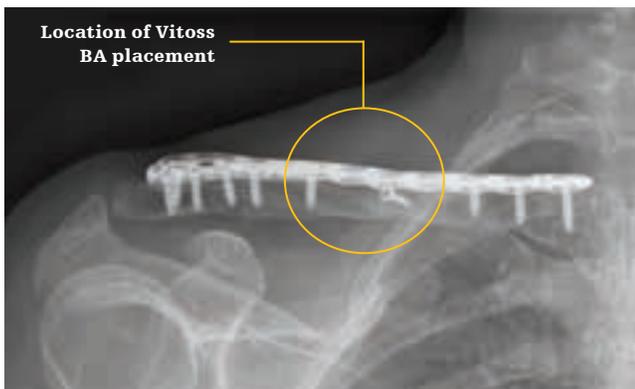
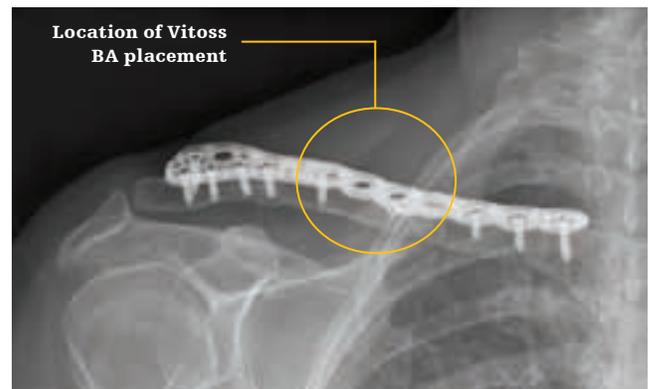
Figure 5B:

Figure 5A: 6 months post-op
